Honza Group Incorporated

Electronic Leak Detection

ELECTRONIC LEAK DETECTION:

A QUALITY ASSURANCE TOOL

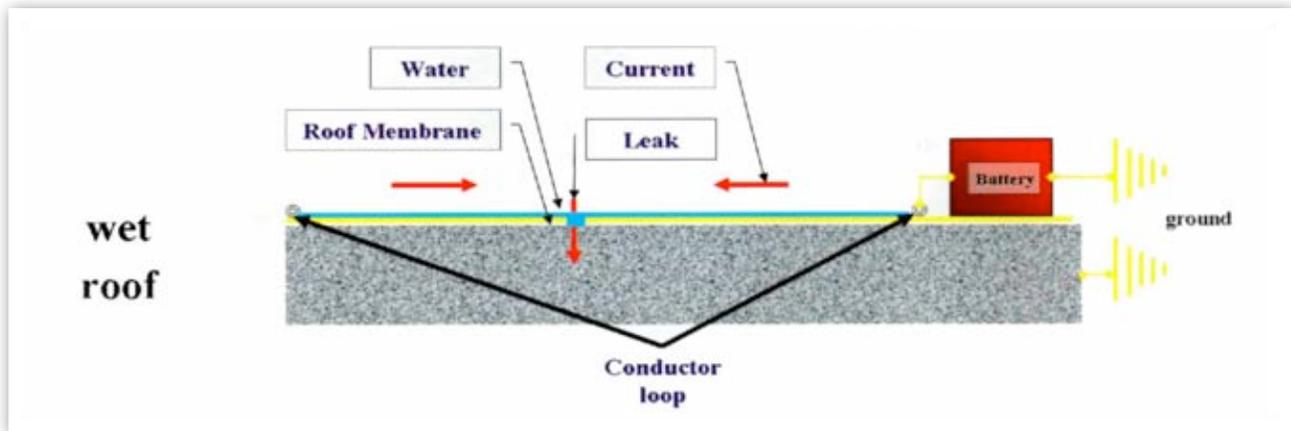
A wire loop, to act as a conductor, is placed directly on the membrane or the membrane's protection course around the perimeter of the area to be tested. One of the two leads from a pulse generator is connected to this wire loop conductor. A second lead from the pulse generator is grounded to the structural deck. The surface of the waterproofing must be wetted (not flooded) to provide an electrically conductive medium.

Every few seconds a low-volt charge is delivered from the pulse generator for one second, as a result, an electrical potential difference is set up between the roof surface, which is wet, and the roof deck, which is "earthed" or grounded – essentially producing two electric plates. If there are any "leaks" or breaches through the waterproofing membrane, which acts as an electric insulator, the small electric current will flow across the membrane surface and down through the breach, completing the circuit between the two "electric plates."

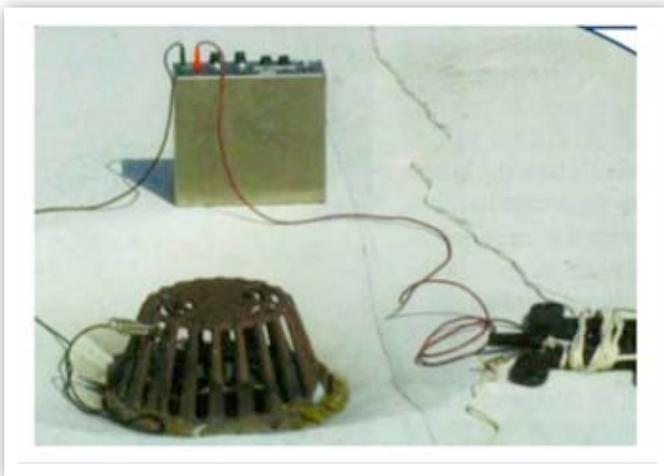
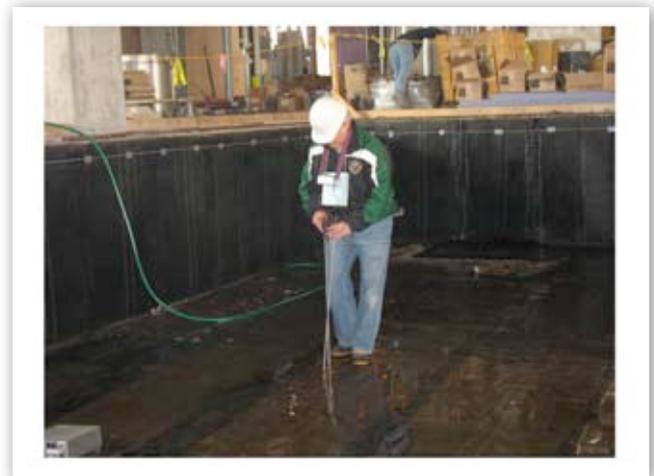
A technician uses a receiver connected to two probes, to identify the direction of the electric current. By moving the probes the technician is able to systematically follow the flow to even the smallest breach or leak through the membrane. Once located, the breach in the membrane can be repaired and quickly retested.

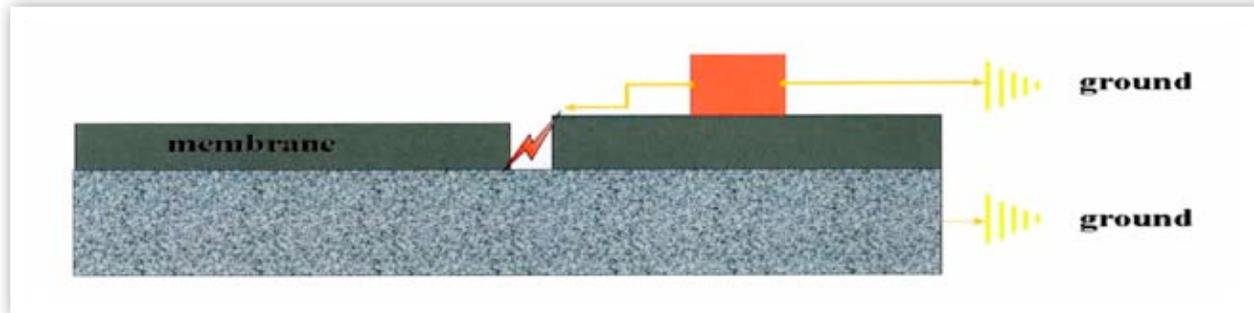
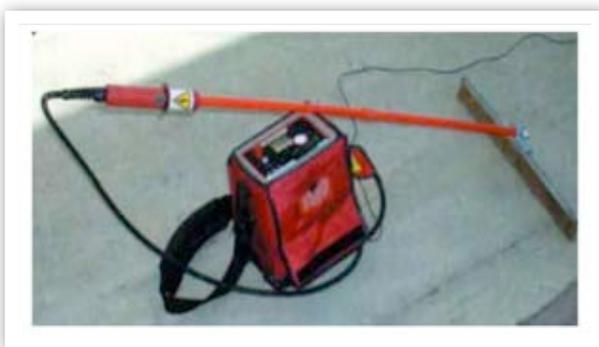
The power source like Low Voltage ELECTRONIC LEAK DETECTION is still grounded to the conductive deck and the membrane acts as an insulator. When the broom head which is made of small conductive bristles makes its way over a breach in the membrane the circuit is completed, allowing current to flow and the power source then emits an audible tone to alert the operator. When the bristles have located a breach within the area of the broom, the operator will then sweep that area again, however this time the contact area is reduced to pinpoint the exact location.

A continuous higher voltage charge than produced by the low voltage pulse generator is delivered from the generator to the piece of testing equipment. With the electrical potential difference between the grounded roof deck and high voltage testing equipment we essentially have two electric plates. If there are any breaches or punctures through the waterproofing membrane, which acts as an electric insulator, the electric current will ground itself at the breach.

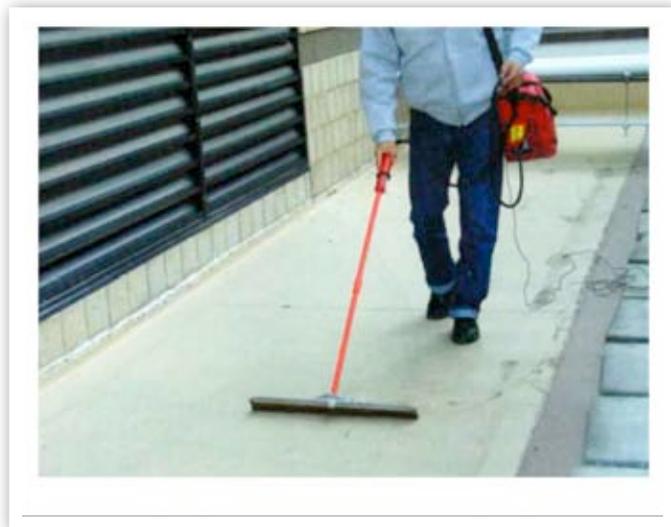
Sample Breach Location / Report

1. All breaches are identified on the membrane and numbered.
2. Each numbered breach is photographed.
3. All breaches are plotted on a roof plan.
4. Report is submitted with roof plan, plotted breaches and photographs.

Number 1 - Puncture
Location (Feet) - 161' / 10.5'

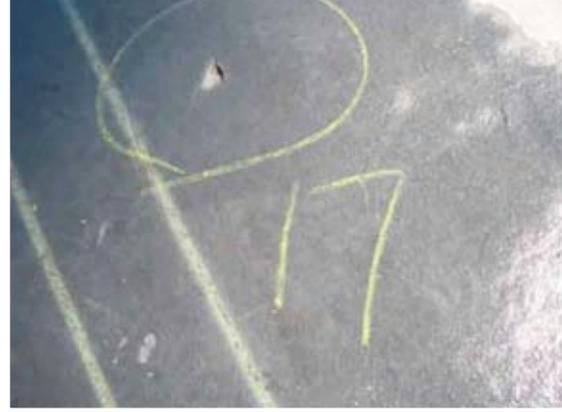
Number 17 - Puncture
Location (Feet) - 5' / 12.5'

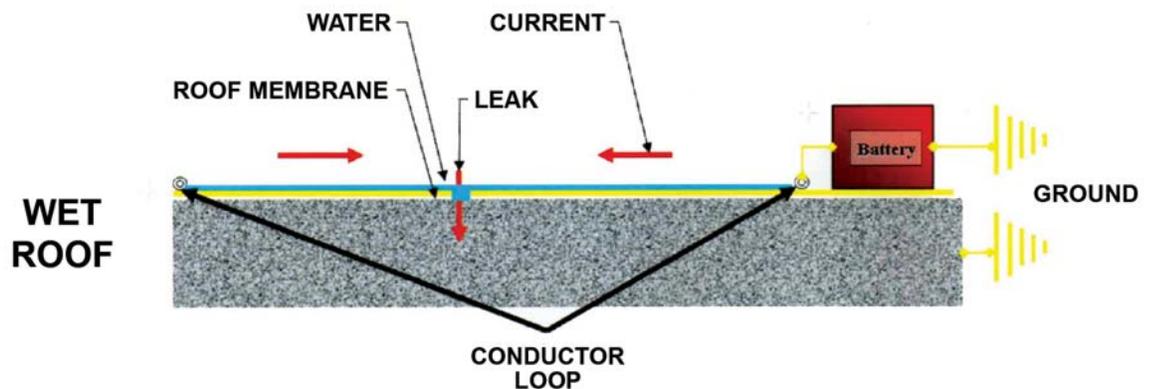
Figure 1 – The surface of the waterproofing must be wetted to provide an electrically conductive medium.

A wire loop, to act as a conductor, is placed directly on the membrane or the membrane’s protection course around the perimeter of the area to be tested. One of the two leads from a pulse generator is connected to this wire loop. A second lead from the pulse generator is grounded to the structural deck at a drain, vent pipe, flashing, or other grounded roof component. The surface of the waterproofing must be wetted (not flooded) to provide an electrically conductive medium (Figure 1).

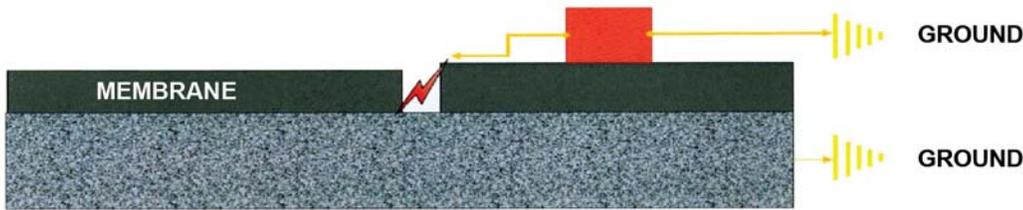
Figure 2 – The power source is grounded to the conductive deck, with the membrane acting as insulator.

With high-voltage ELD, the power source is grounded to the conductive deck, with the membrane acting as an insulator (Figure 2). The other lead is attached to the testing equipment. The testing equipment looks much like a broom. The difference, for ELD purposes, is that the bristles are small conductors. When the broom is swept across the membrane and over a breach, the circuit is completed, allowing current to flow, resulting in the unit emitting an audible tone. When a breach has been initially located within the electronic field of the broom, the operator sweeps the area again with the contact area reduced to pinpoint the exact breach location.

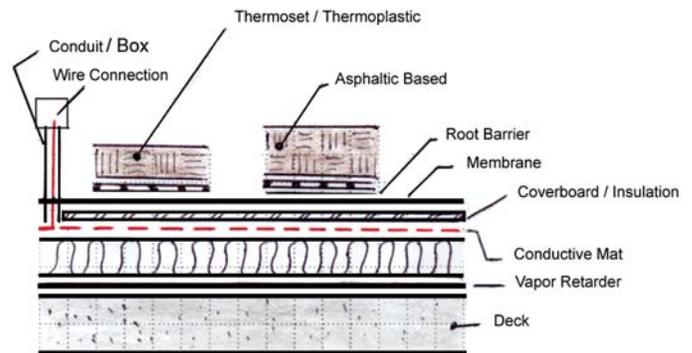
Figure 3 - Testing at nonconductive decks or conductive decks with vapor retarders.

Wood decks are not conductive, and vapor barriers break current flow on conductive decks. These assemblies can be tested if a conductive layer (such as aluminum screening) is included in the membrane assembly. The conductive layer will need to have a wire run to a location above the membrane so that the company performing the testing can use the lead to connect to the ground (Figure 3).

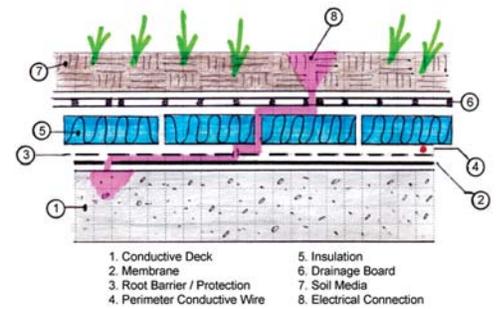
Figure 4 - ELD section with overburden in place.

tors desire to keep the wiring in place so that the system may be used permanently. This can be done, but there are limitations (Figure 4). These include:

- Accuracy in leak location is diminished. On a vegetated roof, a three-dimensional electronic field is now being created due to the depth of the soil. The electrical flow is shaped like an inverted cone. The deeper the soil, the larger the cone.

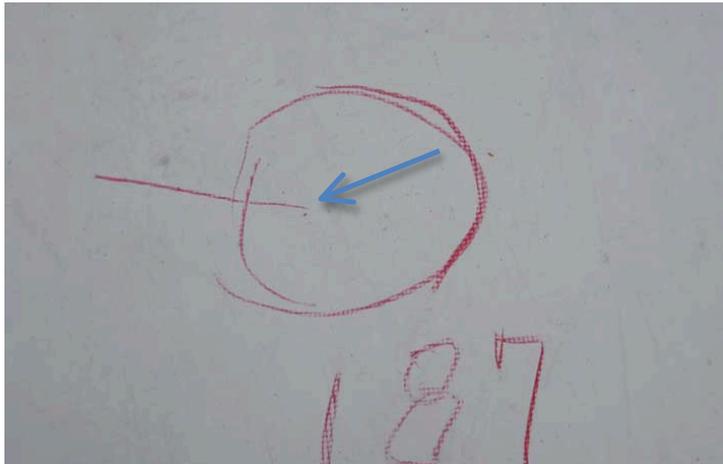
(Pinhole – some are so small they appear to just be a spec of dust.)

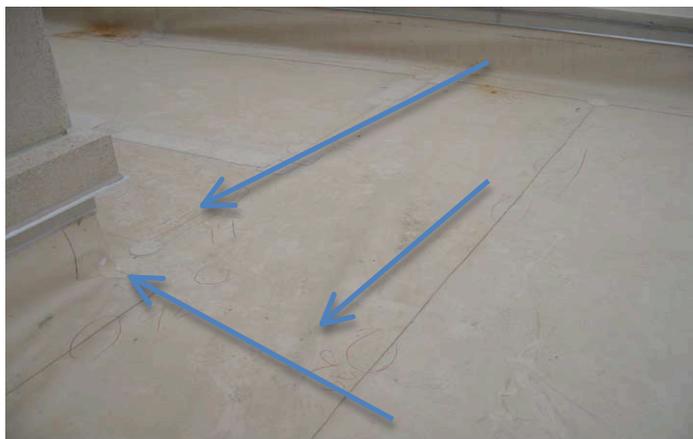
Electronic leak detection testing identified hundreds of breaches including punctures, and lap failures that had previously gone undetected.
